Journal of the
National

A Forensic Engineering Investigation of a Ladder Failure

By Nicholas A. Petrucci, P.E., C.S.P. (NAFE 650M)

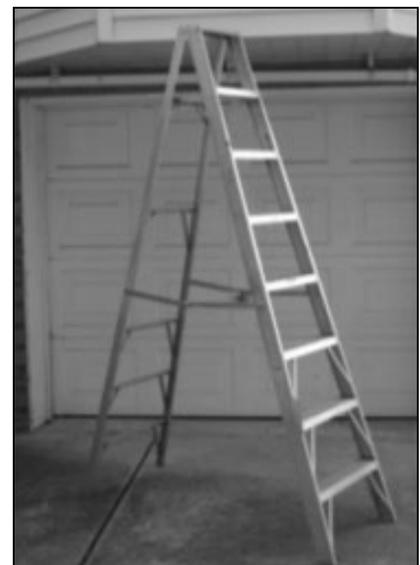
Figure 1
Overall View of the Ladder

The incident ladder was an eight foot aluminum step-ladder with a duty rating of 225 lbs. The change in elevation between each step was one foot. An overall view of the ladder is shown in Figure 1. A label affixed to the ladder referenced ANSI A14.2-1981.

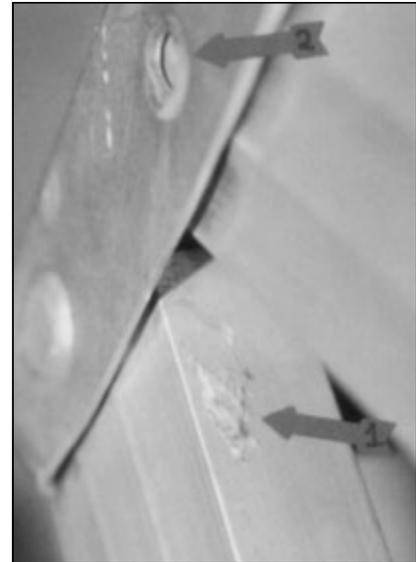
The overall condition of the ladder was poor. Various scratches, abrasions, deformations, wear marks, etc., indicate that the ladder was used, at times improperly, relatively frequently since it was placed in service. Two rivets secure each of the front rails to the top cap, and one rivet secures each of the rear rails to the top cap. The rear rivet that secures the left-front rail to the top cap was missing (see Figures 2 and 3), and was not recovered. Also shown in Figure 2 are gouge

marks on the left-rear rail that appeared to be relatively fresh and consistent with an impact from the top-rear edge of the left-front rail. Several other ladder rivets were loose and/or distressed. The foot of the left-rear rail was missing (see Figure 4). The other ladder feet were significantly worn to the point that the metal foot clamps would contact the ground surface when the ladder was in use. The wear on the feet of the front rails was most severe toward the front of the ladder (see Figures 5 and 6). Additional areas of noteworthy damage to the ladder were the downward deformation of the center portion of its top cap and bent diagonal braces that support the first step of the ladder and the lowest cross brace between the rear rails.

Figure 2
Missing Top Cap Rivet (Arrow 2) and
Rail Gouge Marks (Arrow 1)

During the inspection of the ladder, its lower steps were carefully ascended. The stability of the ladder significantly decreased with each ascending step. The origin of this instability was at the location of the aforementioned missing rivet that previously secured the top cap to the left-front rail. Fresh gouge marks on the left-rear rail are consistent with an impact from the top-rear corner of the left-front rail as a result of the rivet failure. It is therefore reasonable to conclude that the missing rivet was in place immediately before the incident, and that its failure caused the ladder to become unstable and the Plaintiff to fall from it.

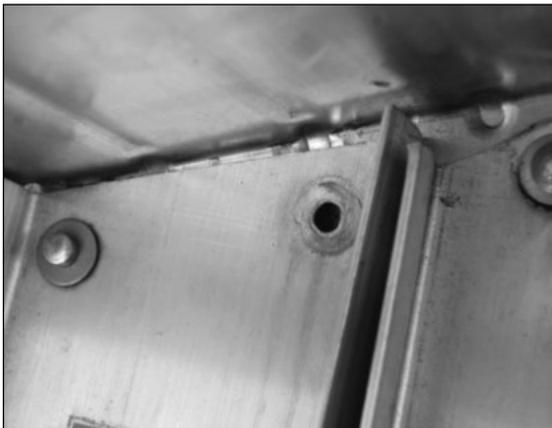
Figure 3
Inboard Side of the Ladder at the
Failed Rivet Location

Figure 3 shows the inboard side of the rear rail where the failed rivet was installed. The other rivet that secured the top cap to the left-front rail was likely set in the same manner as the failed rivet. That is, the tenon of a rivet with a head on one end was inserted through corresponding holes in the top cap and rail from the outboard side of the ladder. A washer was then placed over the tenon. A blunt axial force was applied to the end of the tenon to expand its diameter and secure the washer and thereby the rivet.

Work hardening of a metal occurs when it is cold worked and plastically (i.e., permanently) deformed. While this occurred at the end of the tenon of similar remaining rivets, there was likely minimal plastic deformation in the portion of the rivet tenons that was subject to maximum shear loading.

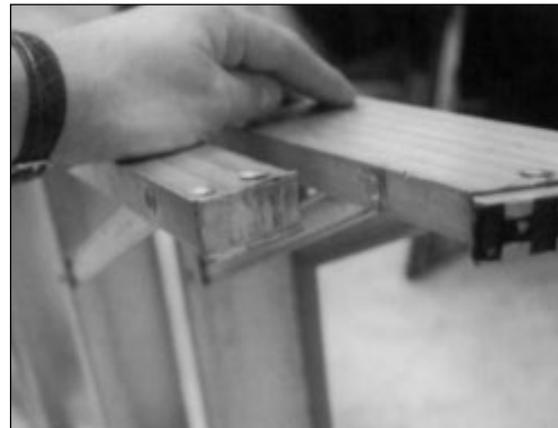
Figure 4
Missing Foot from Left-Rear Rail

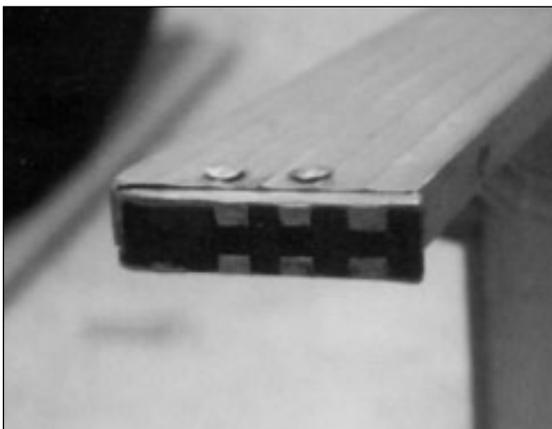
Figure 5
Wear of Right-Front Rail Foot

Of the observed pre-incident damage to the ladder, the wear pattern on the feet of the front rails was one of the more relevant factors with respect to the failure of the missing rivet (see Figures 5 and 6). The wear of these feet is more severe toward the front of the ladder. This indicates that the ladder was moved on numerous occasions by pulling and dragging it by one of its upper steps. The associated vibrations would have resulted in dynamic and cyclical loading of the failed rivet. This loading and that from regular usage likely weakened the rivet prior to its failure.

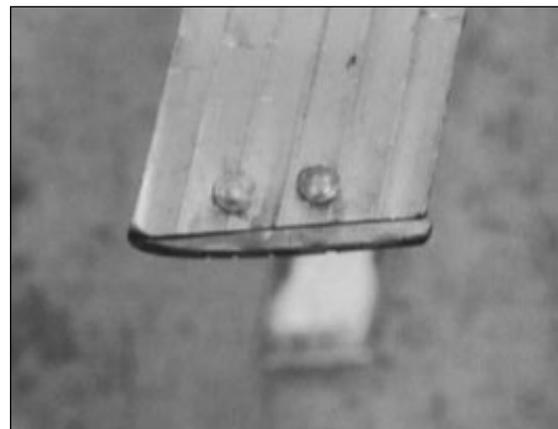
Figure 6
Profile of Right-Front Rail Foot Wear

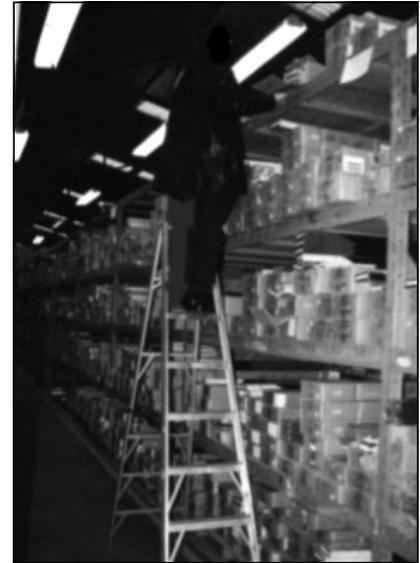
- The Plaintiff was using the ladder to place 3 feet by 2 feet (other dimension not specified) boxes of bed pillows on the top shelf of a set of storage racks (see Figure 7). The top shelf was between 10 and 12 feet above the floor. The incident occurred at 1:30 pm. The Plaintiff first used the ladder at 1:00 pm that day.

- At the time of the incident, the Plaintiff had been waiting for another pallet of pillow boxes while standing on the fifth or sixth step of the ladder for a couple of minutes. He was between the front rails of the ladder, facing the ladder, and motionless.

Figure 7
Representative Pre-Incident
Position of Plaintiff

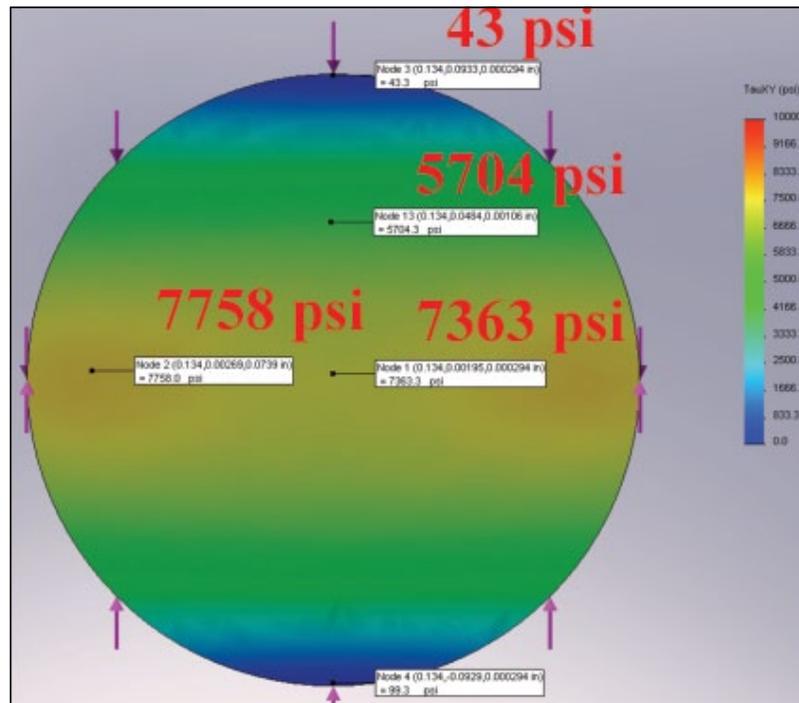
The FEA shear stress plots shown in Figures 8 and 9 are near the axial mid-point of the rivet. Recall that the calculated maximum shear stress in the rivet using the $\tau = 1.33V/A$ formula was approximately 7,700 psi., which is reasonably close to the maximum shear stress of 7,758 psi shown in Figure 8 (uniform distributed loading). The maximum shear stress shown in Figure 9 (concentrated loading) of 8,662 psi is approximately equal to $1.5V/A$. It is expected that a more elaborate analysis utilizing a

more realistic non-uniform distributed loading (i.e., greatest loading at the top and bottom of the rivet that diminishes rapidly toward the ends of the neutral axis) would result in a maximum shear stress near 7,900 psi (i.e., $\tau \sim 1.38V/A$) at the mid-point of the neutral axis as noted above. Using the average shear stress equation (i.e., $\tau = V/A$) yields a shear stress value of approximately 5,800 psi. Selected locations of this average shear stress value are shown in Figures 8 and 9.

The FEA shear stress plots show a shear stress distribution that is generally consistent with near zero shear stress at the top and bottom of the rivet and the maximum shear stress at the neutral axis that is reasonably close to the calculated value. Although an approximation by nature, the FEA stress plots tend to confirm that $\tau = 1.33V/A$ would be a more appropriate equation to determine the maximum shear stress in the rivet than $\tau = V/A$.

FEA Shear Stress Approximation – Uniform Distributed Load

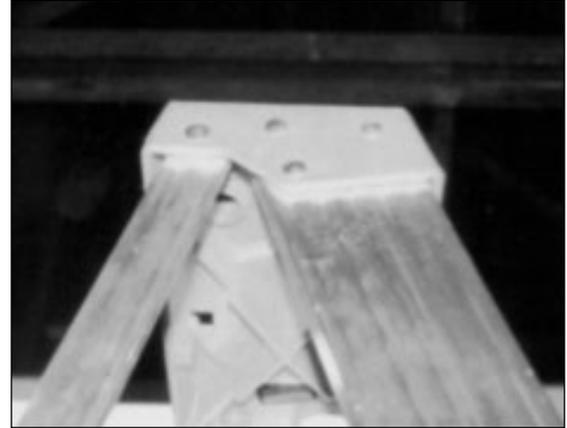
Figure 10
Exemplar Ladder –
Two Rivets at the Failed Rivet Location

These three factors increased the calculated factor of safety from 1.7 to nearly 10.0. Further, many ladders use two rivets at the location of the failed rivet (see Figure 10). This will further reduce the stress in the rivets that secure the top cap to the front ladder rails and add redundancy at a critical location.

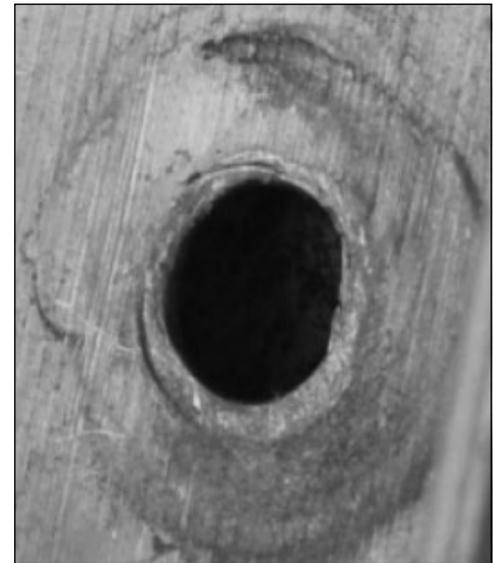
Although the analysis presented above proved to be helpful in resolving the case at hand, it may have been of limited relevance regarding the actual rivet failure. Figure 11 shows a close-up view of the prominent markings on the rail surface from the rivet washer, along with a predominately vertical elongation of the rivet hole in the rail. Therefore, the rivet may have failed as a result of a shear failure or its washer being pulled from its tenon. However, attempting to prove the same and the potential associated defects without the rivet or the washer would not have been a worthwhile endeavor.

Figure 11
Close-up view of the inboard surface of
the rail where the rivet was located.
Refer to Figure 3
